# Inspection Report

Property Address:  
1234 Slick Lane  
Chicago, IL

## Inspectrum, Inc.

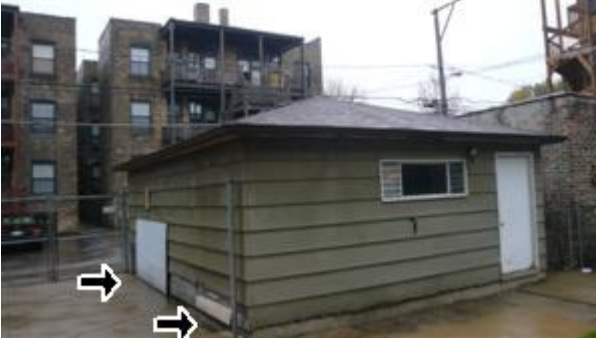
8.4 Picture 1

THE MASONITE TYPE SIDING IS IN POOR CONDITION, REPLACE AS NEEDED.

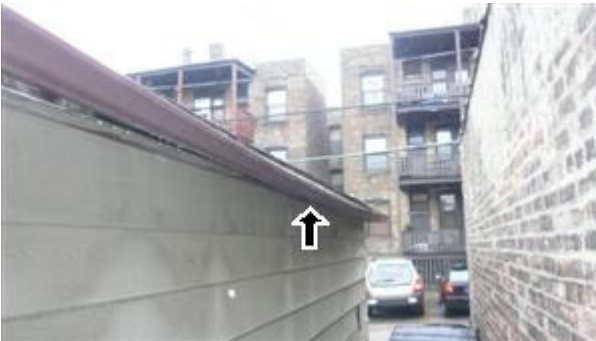
8.6 Picture 1

THE GUTTERS ARE FULL OF LEAVES AND NOT PROPERLY PITCHED TO DRAIN WATER. THE WEST SIDE GUTTER SAGS NEAR THE CENTER

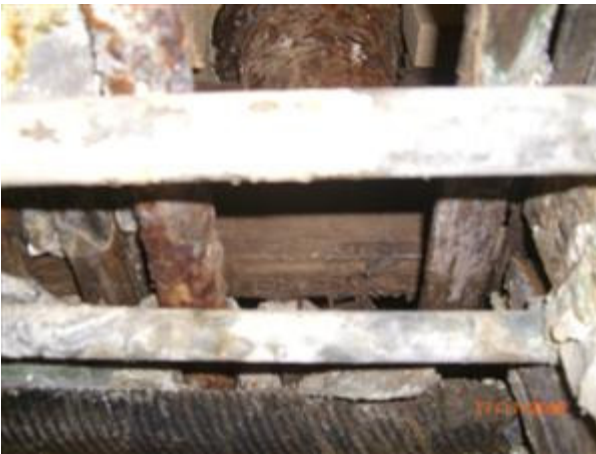
12.9 Picture 1

MOISTURE STAINS/DAMAGE BELOW THE 1ST FLOOR BATHROOM IN THE BASEMENT - TESTED DRY NOW - MOST LIKELY FROM THE TOILET ABOVE - REPAIR( Picture 1 )

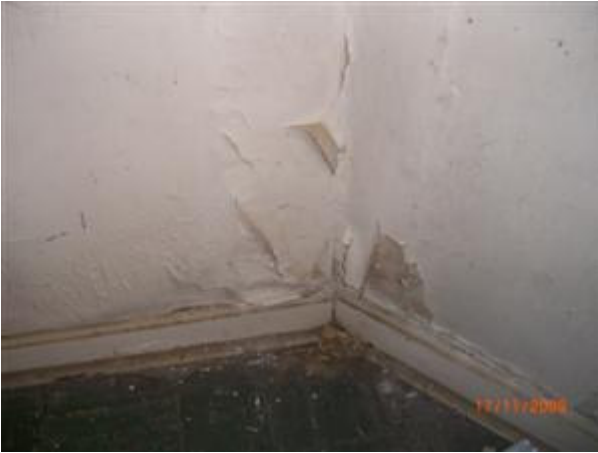
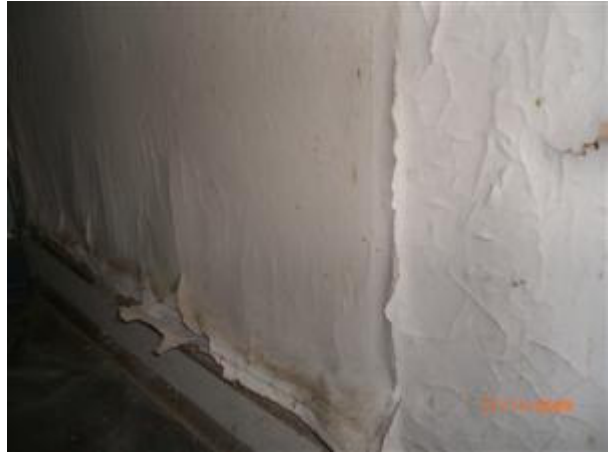
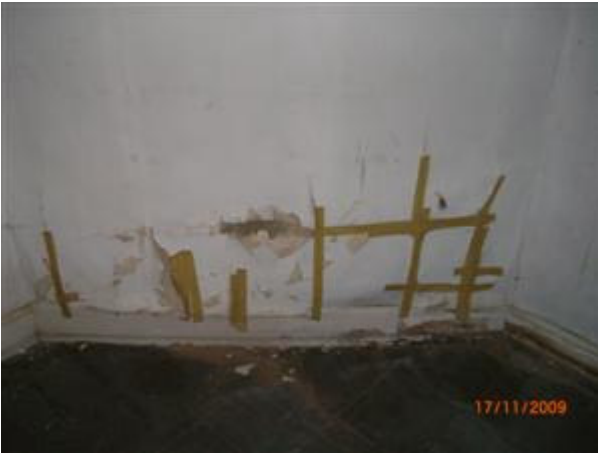
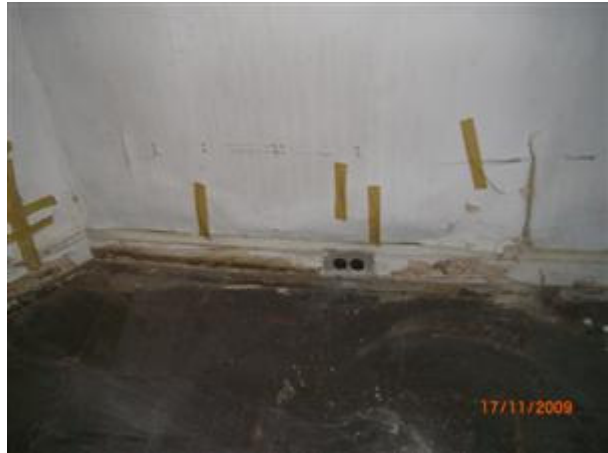
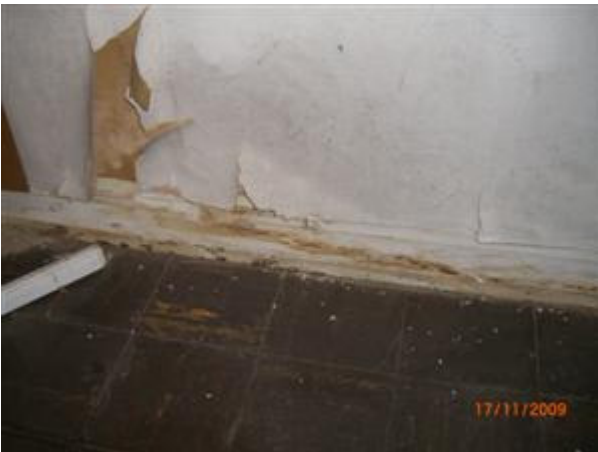
- MOISTURE STAINS/DAMAGE ON THE EAST WALL IN THE BASEMENT - TESTED POSITIVE WITH A MOISTURE METER - INQUIRE INTO SOURCE AND REPAIR( Picture 1 ) ( Picture 2 ) ( Picture 3 ) ( Picture 4 ) ( Picture 5 )
- POSSIBLE MOLD TYPE SUBSTANCE ON THE NORTH AND EAST WALLS IN THE BASEMENT - RECOMMEND FURTHER EVALUATION BY A LICENSED MOLD REMEDIATION PROFESSIONAL ( Picture 6 )

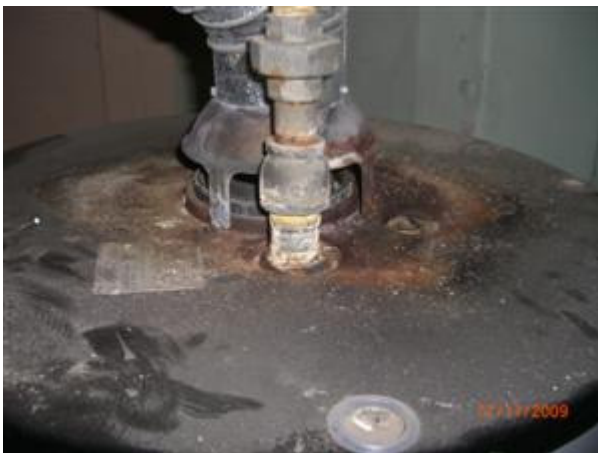
20.0 Picture 1

- WATER HEATER IS ABOUT 9 YEARS OLD - TYPICAL LIFE EXPECTANCY IS ABOUT 12 - 15 YEARS - SERVICE REGULARLY
- WATER HEATER TOP IS SCORCHED, APPEARS TO BE DUE TO A SMALL DRAFT HOOD - HAVE SERVICED AND REPAIRED BY A LICENSED PLUMBER( Picture 1 )

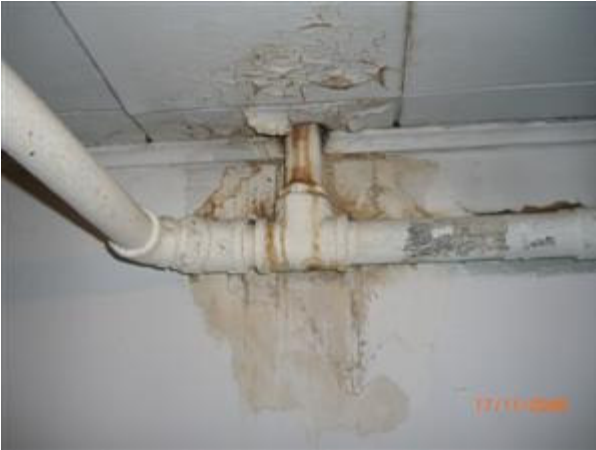
21.6 Picture 1

- SEVERAL RADIATOR HANDLES THROUGHOUT ARE STUCK OR MISSING - REPAIR/REPLACE
- RADIATOR PIPE LEAKING AT THE NORTHEAST CORNER - REPAIR( Picture 1 )

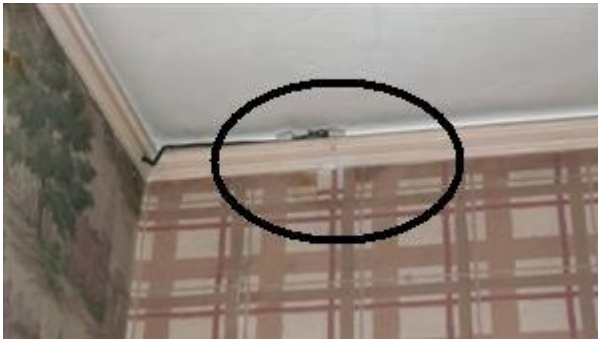
1.5 Picture 1

(2) HANDYMAN WIRING EVIDENT OVER THE FOYER DOORWAY, HAVE REPAIRED.

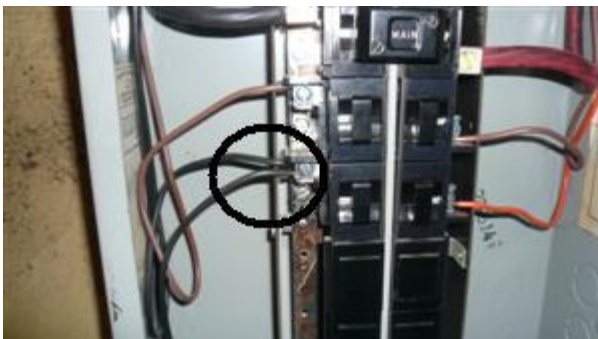
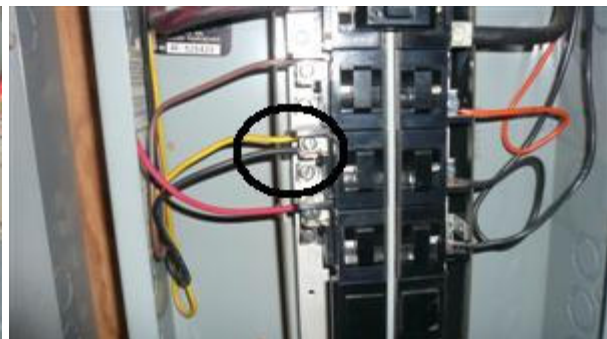
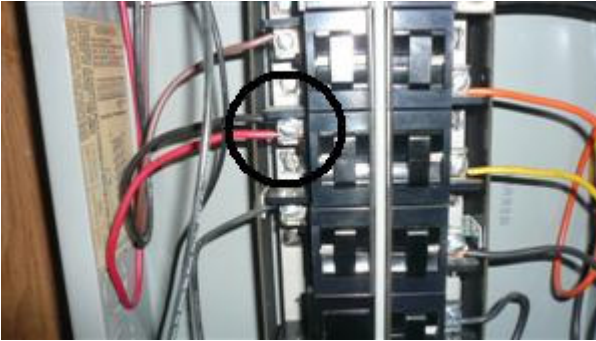
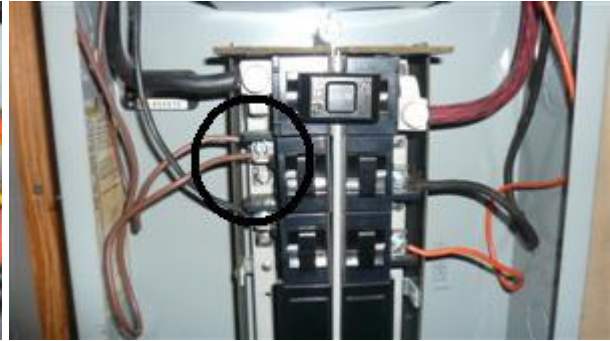
EVERY PANEL HAD AT LEAST ONE DOUBLE TAPPED BREAKER, HAVE REPAIRED.

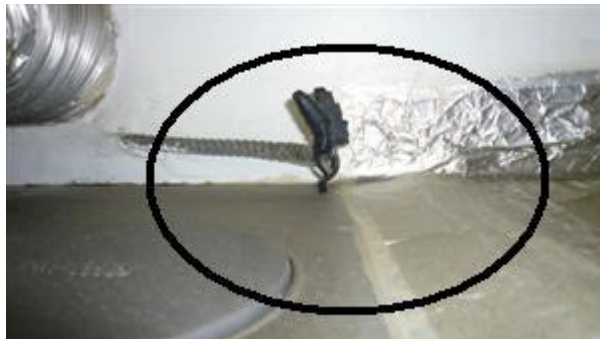
14.19.B Picture 1

HANDYMAN WIRING EVIDENT AT THE EXHAUST FAN, HAVE REPAIRED.

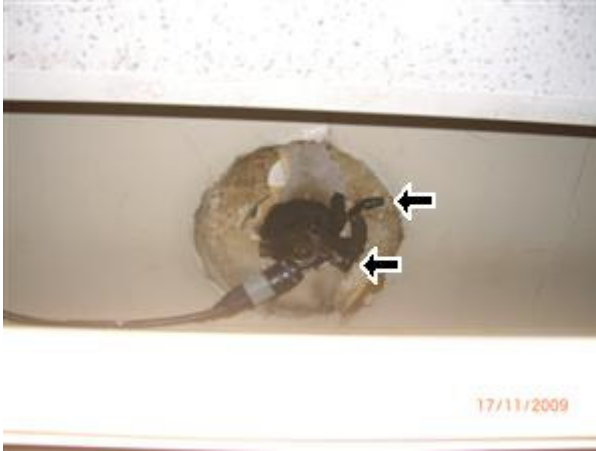
14.13.C Picture 1

CEILING LIGHT FIXTURE AND EXHAUST VENT HOOD ARE WIRED IMPROPERLY - HAZARD - PROFESSIONALLY REPAIR( Picture 1 )

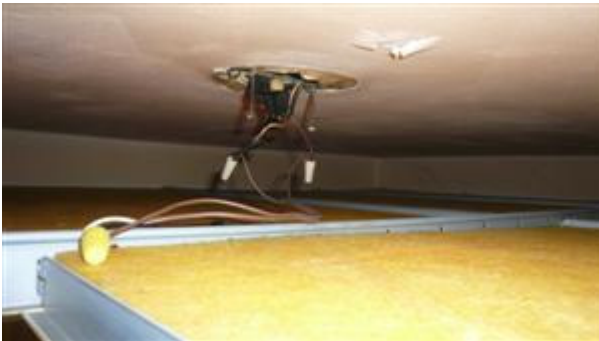
17.6.C Picture 1

- THE NORTH WALL OUTLET IS UNGROUNDED, CORRECT.
- SECURE THE LOOSE WIRES EVIDENT BETWEEN THE DROP CEILING AND PLASTER CEILING.
